Ethics and materials: Some Spanish Cases

Santiago Huerta. Polytechnic University of Madrid

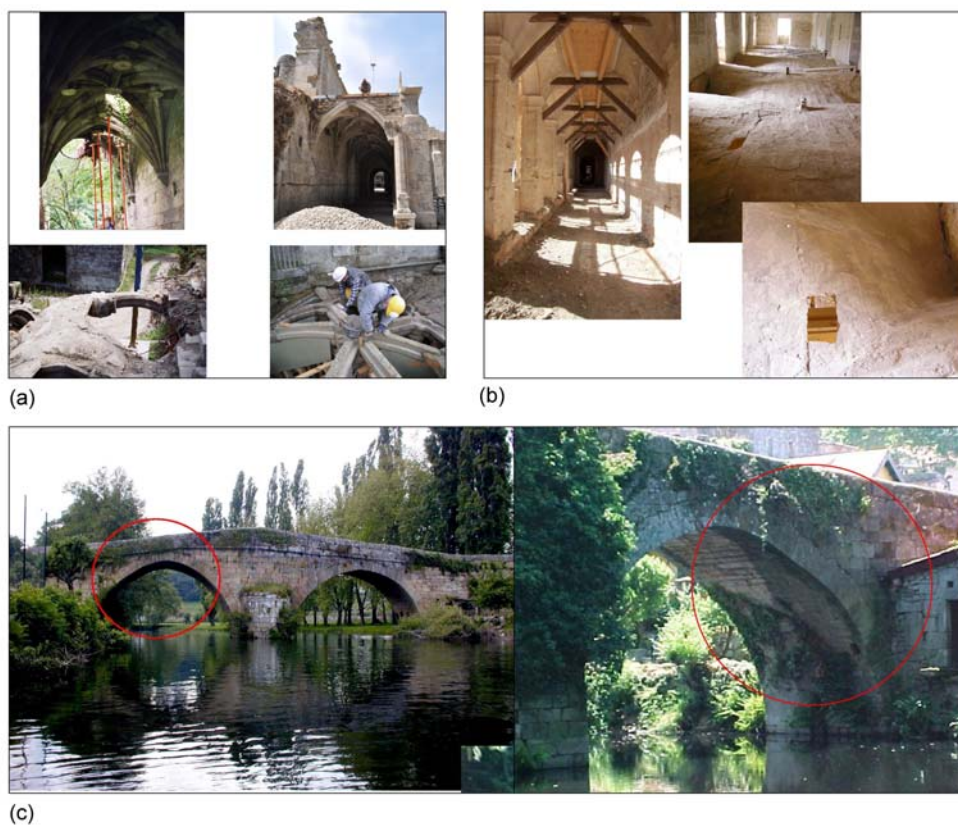
Figure 4

Sometimes the building has to support new, heavier loads. The ruin of the abandoned (since the 19th Century) monastery of Melón should be consolidated, some vaults are rebuilt and the visitors can walk over them (fig. 4a).¹² A Franciscan Convent is going to be turned into a Cultural Centre, the loads to be supported being multiplied by a factor of two (4b).¹³ A little medieval bridge is asked to support the pass of heavy lorries (4c).¹⁴

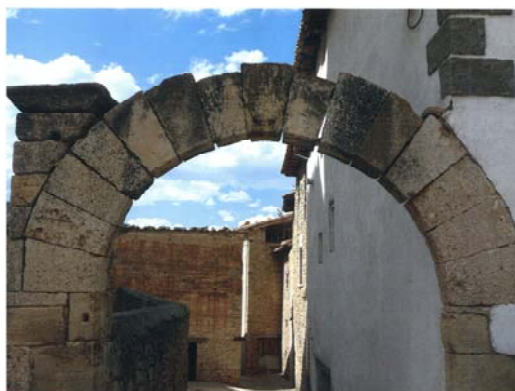
In the front arches in walls or in the transverse arches, the three cracks are clearly visible, Fig. 11 (a). In the case of the barrel vaults of Romanesque or Renaissance churches, the crack at the keystone is clearly visible from the floor, but to see the cracks at the haunches one has to climb to the extrados and, there, maybe remove some of the filling. Many times, the cracks have been closed and the masonry painted so that it is not possible to see them, Figure 11 (b). But the distorted form of the arch is proof of their existence, and, no doubt, most of the thrust is passing through the hinges, the points of contact between the voussoirs. Sometimes, the increase of span is large and the arch or vault is greatly distorted as in Figure 3 (a), above. Now we are able to understand the distortion: the vault divides in two parts which move rotating around the hinges. It is this discrete rotation which produces the distortion, which can not be explained in elastic terms.

Figure 11
Cracks in arches. (a) Simple arch with visible cracks in Tronchón, Teruel; (b) Distorted transverse arches with the cracks closed in the cathedral of Santiago de Compostela (note the useless bronze cramps added)
